SECTION 32 PROGRAM  
STREAMBANK EROSION CONTROL,  
EVALUATION AND DEMONSTRATION  
WORK UNIT 2-EVALUATION OF EXISTING  
BANK PROTECTION

FIELD INSPECTION OF MORAMEAL REVETMENT  
ON THE RED RIVER

September 1979  
Inspection Report 7

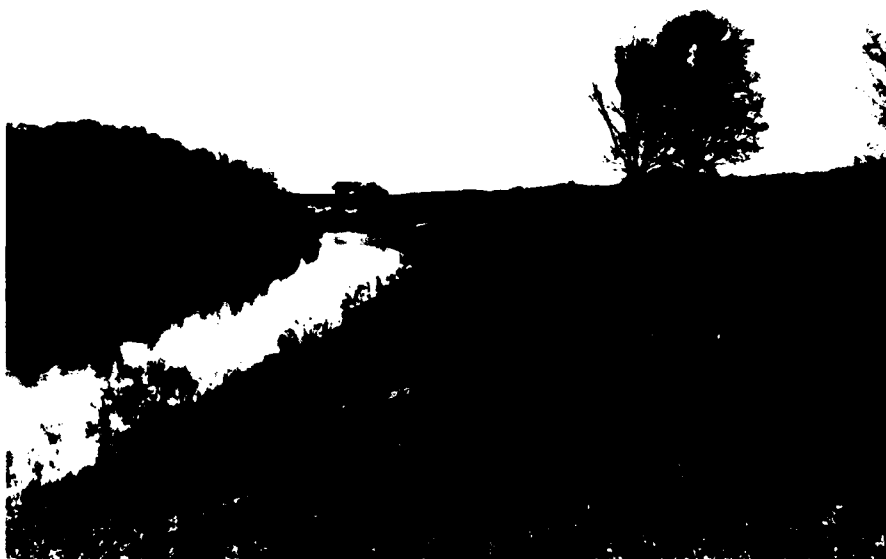
Figure 3. Upstream view of revetment showing spoil bank (left side) constructed with material removed from toe trench and deposited riverward and parallel to the streambank

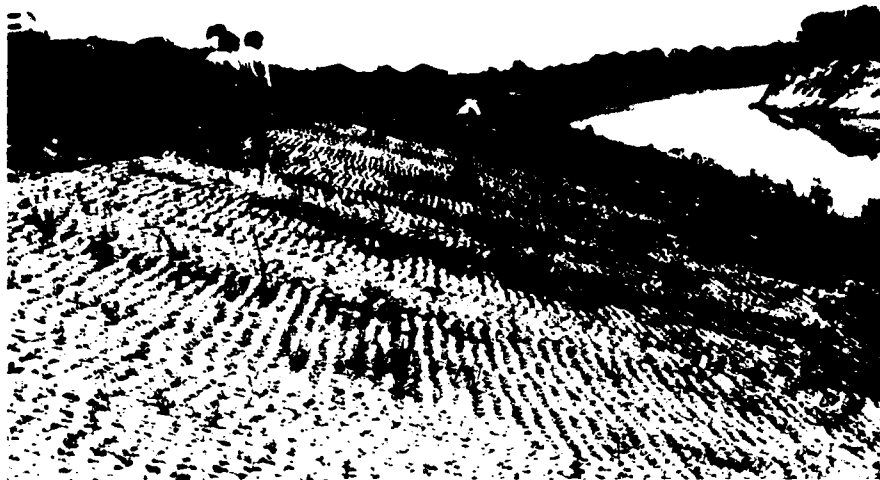
Figure 9. Downstream view of Gobi-Block revetment (Section B). Spoil bank is located in the extreme right portion of photograph

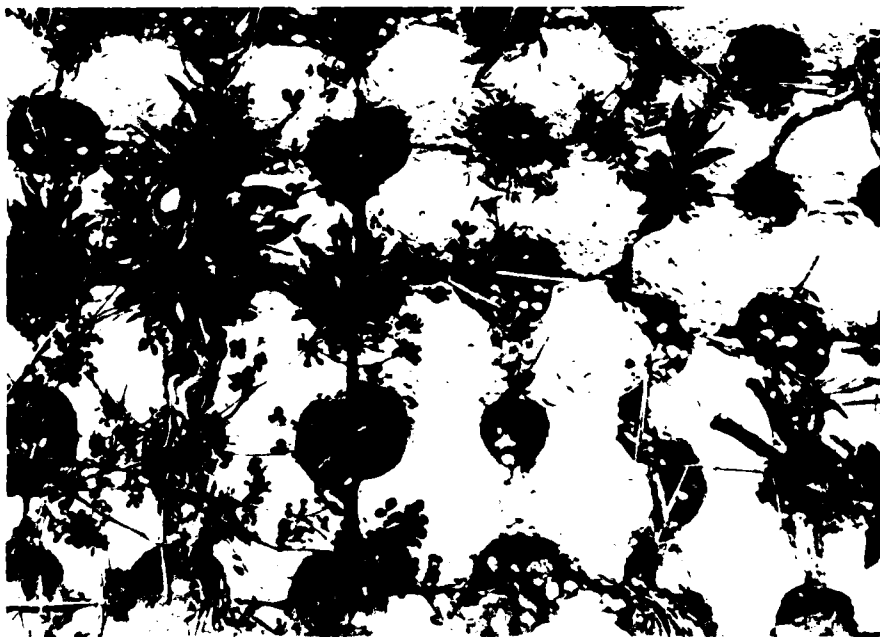
Figure 10. Detailed view of Gobi-Block revetment (Section B)

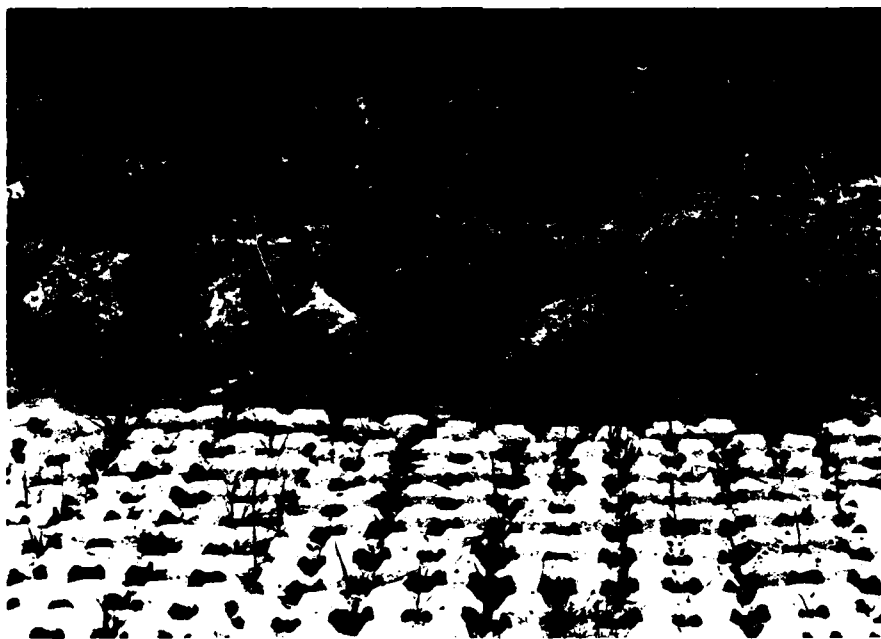
material probably due to the effects of overbank drainage which was also noted landward of Section B (Figure 12). The toe trench of this section was constructed with Type A stone.

Figure 12. Upper bank erosion resulting from overbank drainage (Section B)

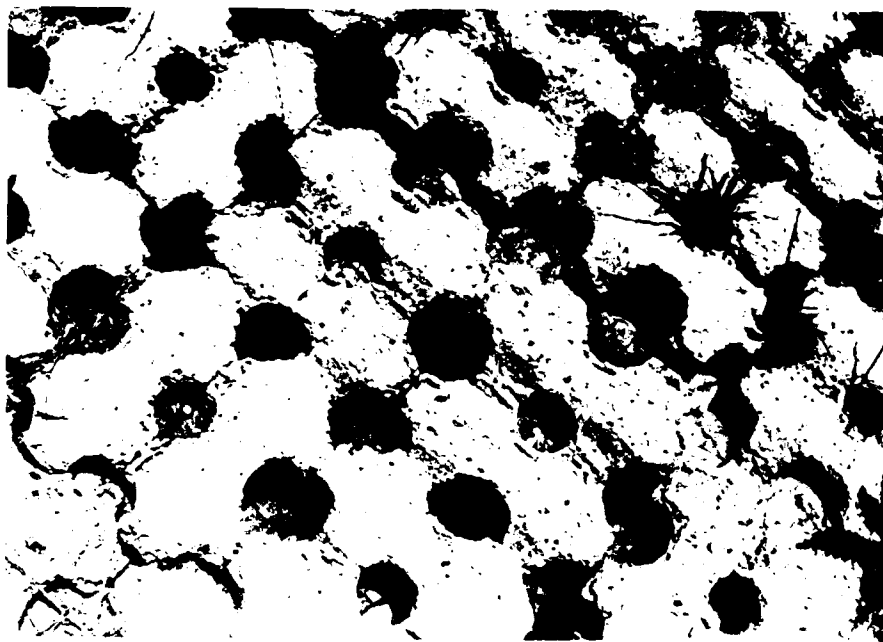
13. At the time of the inspection, the filter fabric was not visible through most of this section because of deposition and the growth of vegetation. The general appearance of the revetment section was not unlike that of Section B (Figure 9). At the few locations where the filter fabric was visible, it seemed to be in good condition (Figure 13). Overbank drainage has removed some of the protective soil covering the fabric at the landward edge of the section (Figure 14); piping beneath the fabric was also noted at several locations (Figure 15). The trench-filled toe of this section was constructed with Type A stone.

Figure 13. Poly-Filter X filter fabric visible through Gobi Blocks (Section C)

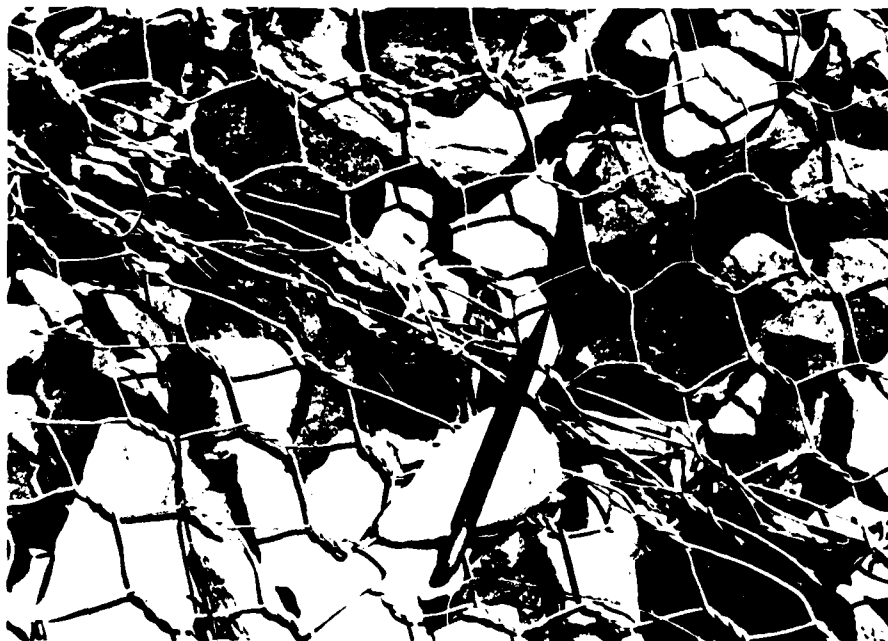
Figure 16. Detail view of rock and wire mattress where two gabions have been wired together (Section D)

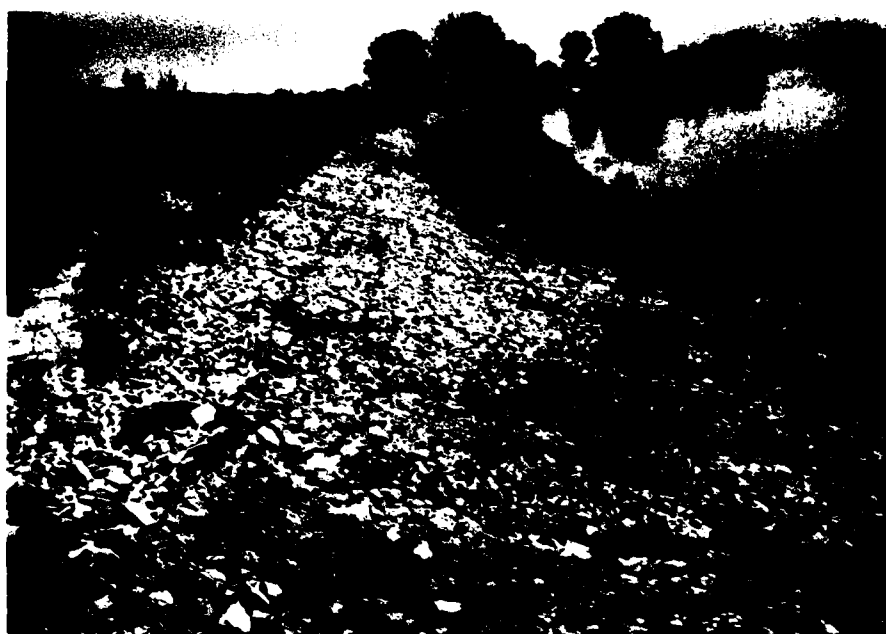
Figure 17. Upstream view of rock and wire mattress  
(Section D)

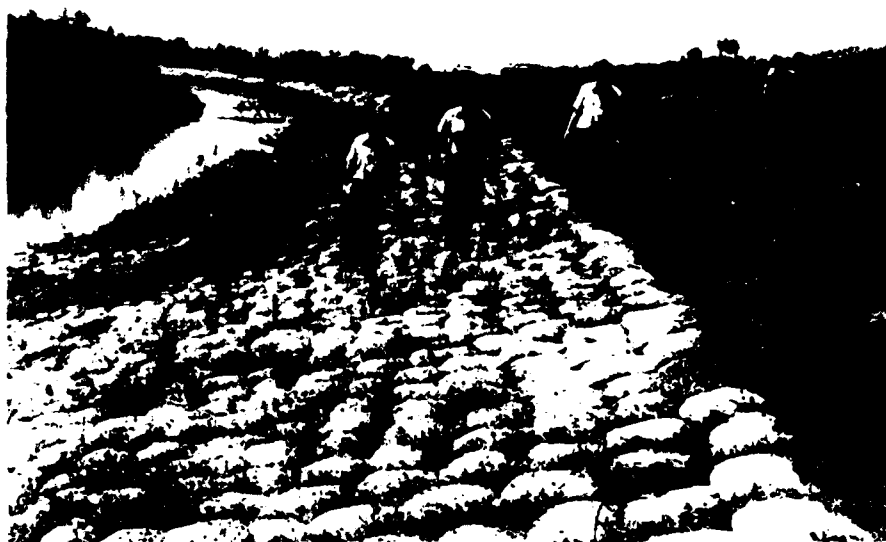
19. The excavated toe trench was filled with bags dumped from a dragline bucket. During the excavation and dumping operation, it was necessary to place a clay plug at the upstream end of the trench and to continuously run two pumps in order to keep seepage water below the elevation of the ongoing work. On the graded bank, the bags were hand-placed and lapped in much the same manner as roofing shingles (Figure 19).

Figure 19. Upstream view of sand-filled acrylic bag test section (Section E). Disposed material removed from the toe trench is located in the extreme left portion of photograph

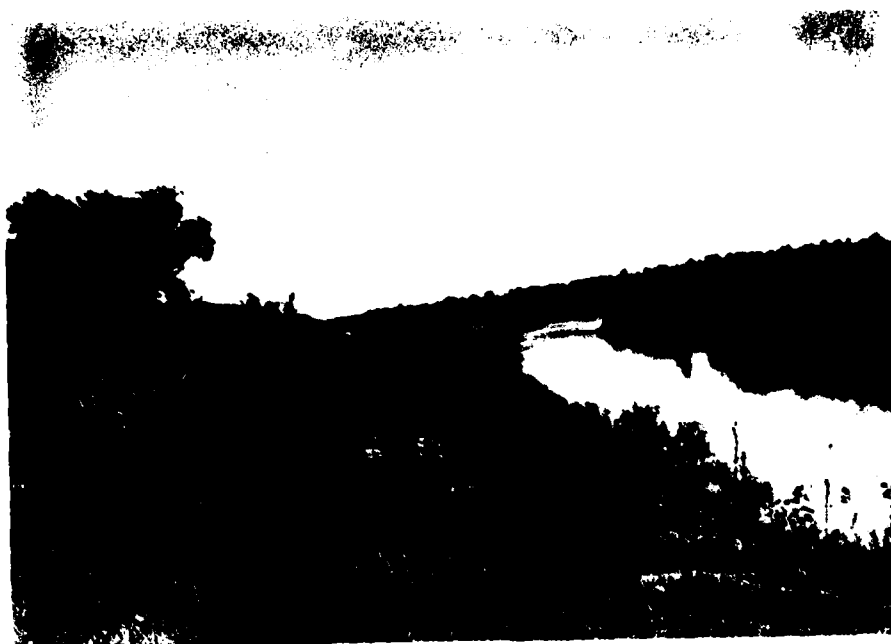
27. The remaining soil-cement in the work area was bulldozed into a layer on the upper bank of this section. This material was mostly fines that resembled the in situ soil. The paved bank was then graded and dressed which resulted in further pulverizing of the soil-cement. Figure 21 shows a downstream view of the completed revetment section as it appeared at the time of inspection; the bare area is exposed soil-cement. A detailed view of a larger soil-cement block is shown in Figure 22.

Figure 21. Downstream view of soil-cement section (Section F). Disposed material removed from the toe trench is located in the extreme right portion of the photograph
